Xerox® VersaLink® Product Enhancements Document for Version xx.75.01

Description of new features and enhancements to the products specified below.

Release Date: March 11, 2024 dc24rn4193

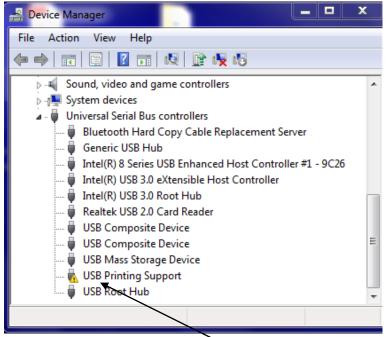
Please reference sheet shot below:

With Device Manager now open, you can now view the list and select [Universal Serial Bus controllers] to identify if the problem is being seen on the Windows Workstation.

<u>Note:</u> Customers who have a <u>Yellow Warning!</u> next to the USB Printing Support will need to Right Click on the USB Printing Support line and select Update Driver Software.
